# 737 Graphite Composite Flight Spoiler Flight Service Evaluation

**Ninth Report**

January 1985 Through December 1986

Prepared Under Contract NAS 1-11668 by Boeing Commercial Airplane Company

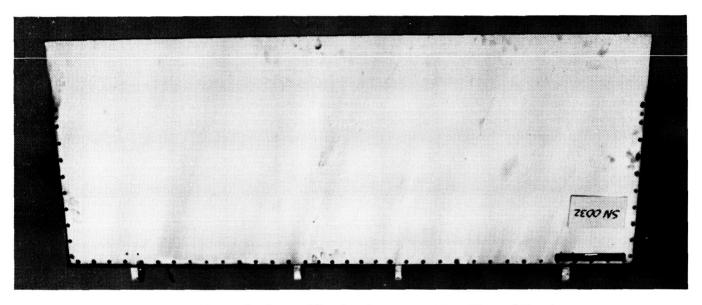
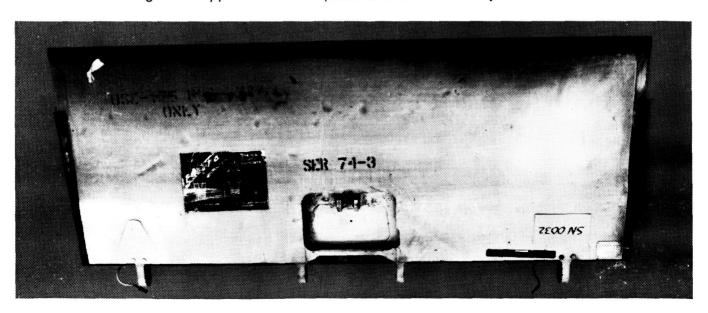
Following selection for test, the units were photographed. Figures 2 and 3 show the upper and lower surfaces, respectively, of spoiler S/N 0032 after 12 years of service. This unit was previously repaired over the center hinge fitting. The repair was sound and this unit was clear of damage.

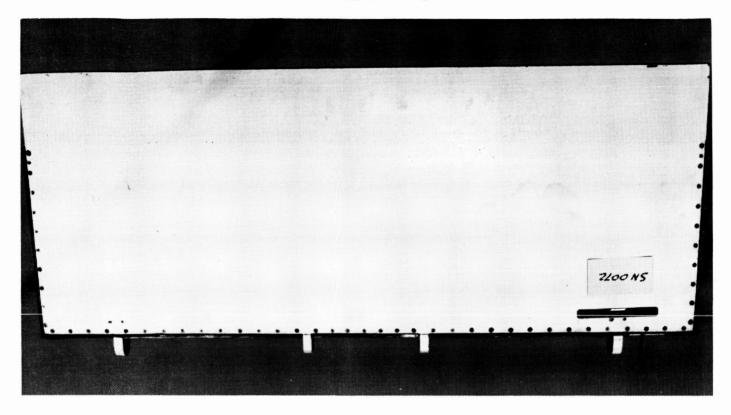
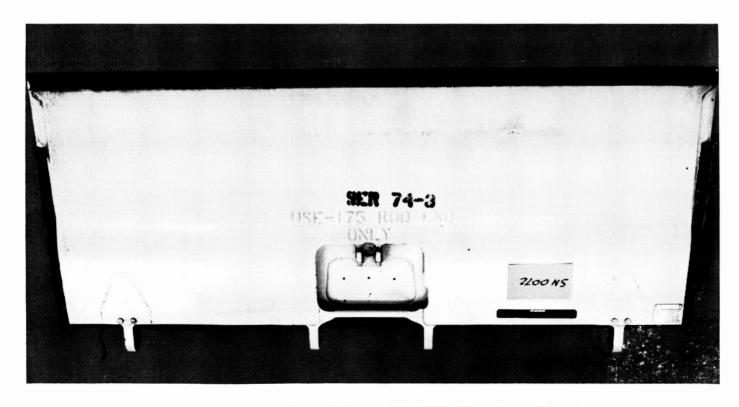
Figures 4 and 5 are photographs of the upper and lower surfaces, respectively, of spoiler S/N 0072 after 12 years of service. This unit was clear of damage.

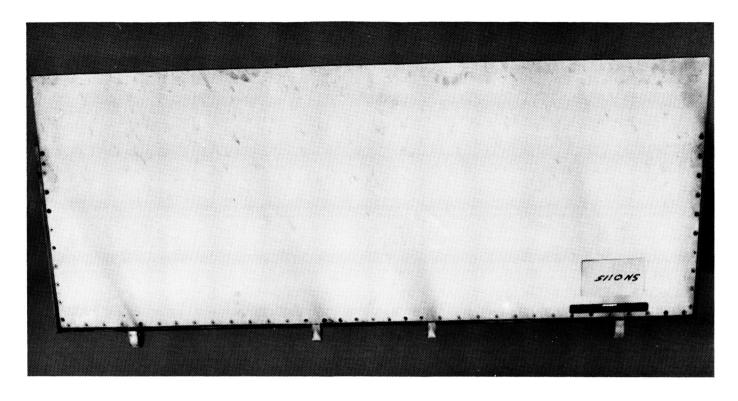
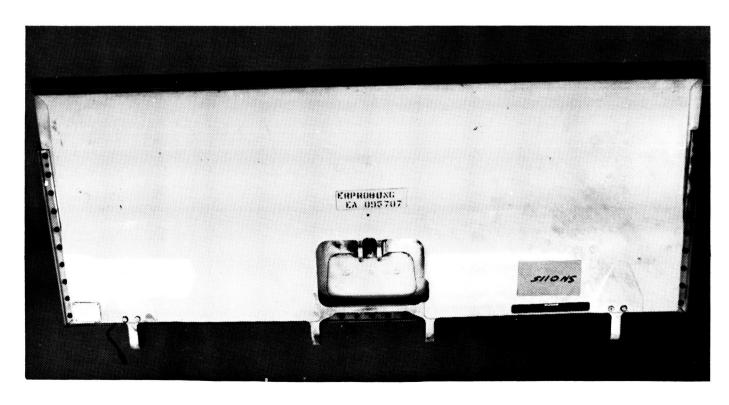
The upper and lower surfaces of spoiler S/N 0115 after 12 years of service are shown, respectively, on Figures 6 and 7. This unit was also clear of damage.

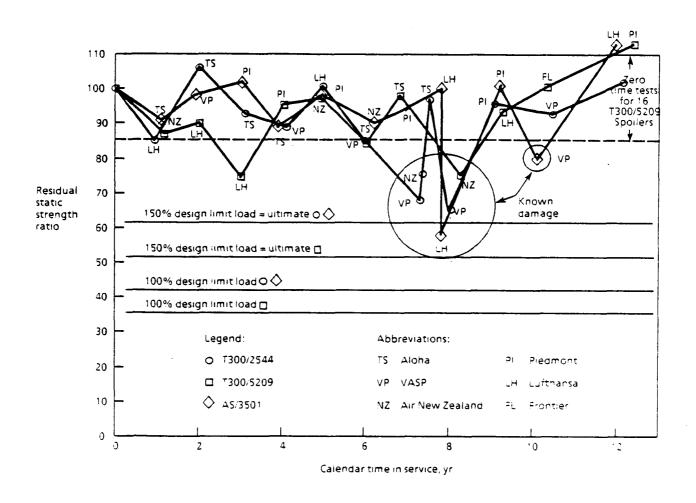
Figure 8. Summary of Residual Strength After Exposure

Table 4 gives data from all of the scheduled twelfth-year removals and summarizes the strength and stiffness data from the three units that were statically tested. Figure 8 shows the residual static strength data accumulated to date. Each symbol represents one test of a particular spoiler dash number (i.e., type of skin material) after a predesigned period of time. Initials near the symbols indicate the airline from which the spoiler was removed. The data are shown as residual strength ratio, where 1.0 is the original unexposed certification test value for each material system. The scatter band for a total of 16 ultimate tests run on unexposed -2 units is shown. Although limited to one production run of only one of the three types of material, the band provides some idea of the scatter that could be expected. The limit and ultimate load requirements for each material system are also shown in the figure. The units with known significant damage all failed above design limit load thus meeting safe operating criteria. Figures 9 through 11 are plots of the load-deflection data for the three 12-year spoilers reported in this document. Figure 12 shows the test setup. Load is applied to the upper surface through an evener system and load pad scheme. The load is then reacted at the four hinge points and the actuator rod end.

The failure loads for the twelfth-year test spoilers are on the high side of the baseline scatter band. In fact, two of the units failed at loads above the scatter band. There is no obvious explanation for this behavior. Calibration checks of the test equipment support the test data. The failure mode of the two high failure load spoilers was related to a higher energy failure mode. For these two spoilers the center hinge fitting was essentially rammed through the upper surface. Typical failures propagate from the center hinge-fitting-to-spar splice and are less catastrophic. Photographs of the spoilers after testing are shown in Figures 13 through 18. These spoilers had no apparent damage or degradation. As a last observation it should be noted that the baseline scatter band was generated from the test of 16 spoilers. With the testing of 36 spoilers after service exposure, the probability of excursions out of the baseline scatter band becomes greater.

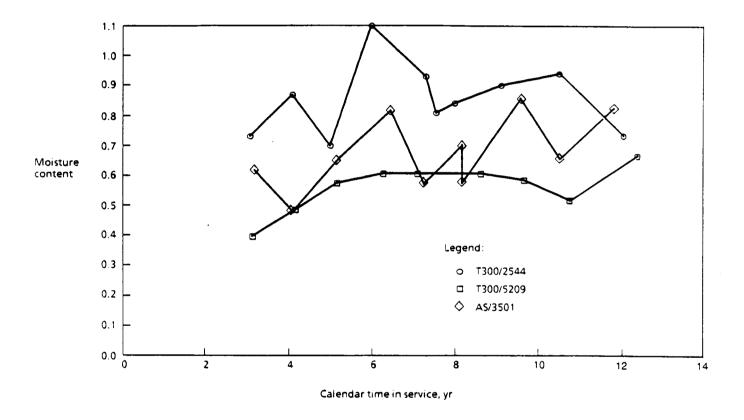
Figure 19. Moisture Weight Loss of Spoiler Core Samples

All core specimens were subjected to a drying environment at 160°F. The samples were weighed in order to construct a final observed graphite-epoxy moisture content. This moisture content data is shown plotted against time on Figure 19.

The moisture contents of the spoiler dryout specimens vary considerably over time relative to other moisture absorption studies (ref. 9, fig. 69). That study found moisture contents stabilizing at 1.90% for T300/2544, 1.00% for AS/3501, and 0.65% for T300/5209 and used 20-ply short-beam shear specimens that were unpainted. The difference in specimen geometry in terms of surface area, thickness, cut edge area, and surface finish may account for the different moisture absorption results. Especially important may be the thickness, in that the

this spoiler skin laminates allow a more rapid absorption-desorption cycle. As a result the measured moisture content may be more sensitive to the exact time in the seasonal cycle the spoiler was removed from service. Another factor is that over the years many of the spoilers have been painted and repainted resulting in variations in paint layer thickness from part to part. The absorption of moisture in the paint has been taken as a constant in this study. As a result changes in paint layer thickness may affect the final moisture content calculation.
